Contract #: 04-0120F4Cty: SF/ALA Rte: 80 PM: 13.2/13.9File #: 69.28**WELDING INSPECTION REPORT****Resident Engineer:**Siegenthaler, Peter**Address:** 333 Burma Road**City:** Oakland, CA 94607**Report No:** WIR-024975**Date Inspected:** 30-Apr-2011**Project Name:** SAS Superstructure**OSM Arrival Time:** 700**Prime Contractor:** American Bridge/Fluor Enterprises, a JV**OSM Departure Time:** 1900**Contractor:** Zhenhua Port Machinery Company, Ltd (ZPMC), Changxing Island **Location:** Shanghai, China**CWI Name:** Xu Le Feng**CWI Present:** Yes No**Inspected CWI report:** Yes No N/A**Rod Oven in Use:** Yes No N/A**Electrode to specification:** Yes No N/A**Weld Procedures Followed:** Yes No N/A**Qualified Welders:** Yes No N/A**Verified Joint Fit-up:** Yes No N/A**Approved Drawings:** Yes No N/A**Approved WPS:** Yes No N/A**Delayed / Cancelled:** Yes No N/A**Bridge No:** 34-0006**Component:** TOWER Components**Summary of Items Observed:**

BLAST SHOP#2**POST BLAST INSPECTION INTERNAL AND EXTERNAL OF TOWER HEAD, NORTH SHAFT LIFT-6****Description of Inspection:**

POST BLAST INSPECTION INTERNAL AND EXTERNAL OF TOWER HEAD, WEST SHAFT LIFT-6**Description of Inspection:**

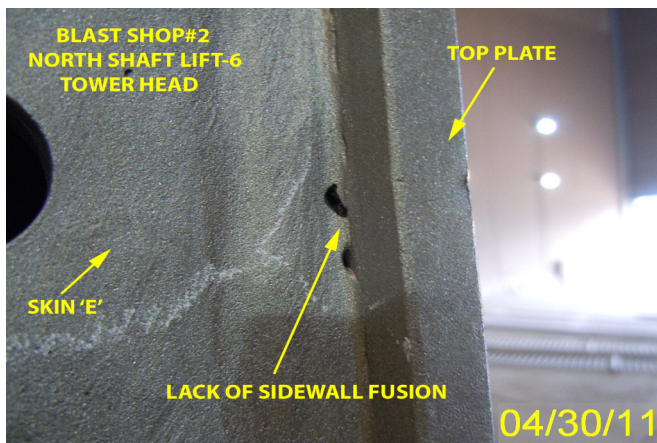
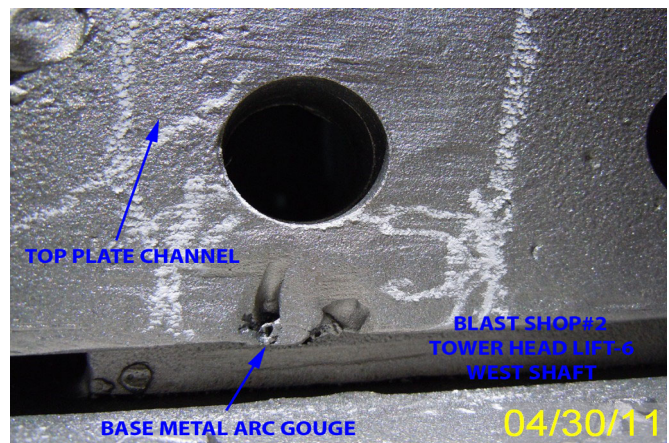
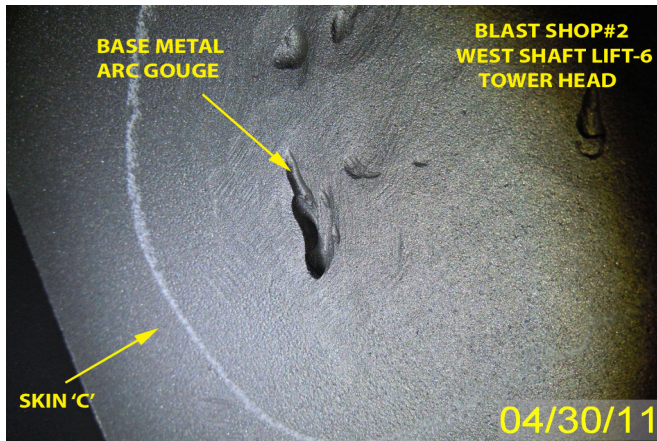
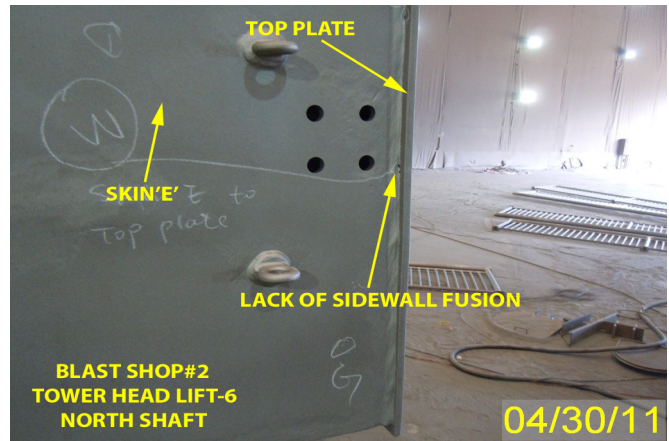
- 1) Internal: Skin 'E' to top plate weld– Lack of sidewall fusion – 450 mm from A/E corner.
- 2) Internal: A/B corner weld bottom side– Porosity – on the face of the weld.

- 1) Internal: Skin 'C' – Base material arc gouge – 90 mm from top plate and 100 mm from B/C corner.
- 2) Internal: Skin 'A' – Base material arc gouge – 2000 mm from A/E corner.
- 3) Internal: Top plate channel – Base material arc gouge – 140 mm from Skin 'A'.
- 4) Internal: G' plate to 'F' plate weld – underfill – top side of the weld.
- 5) Internal: Top plate – Base material arc gouge – on the stiffener near manhole.
